Manhole Inspection Summary

Manhole # S21C1_025MH

Insp Date: **5/21/08 11:23 AM**

Location Address: **2614 paca st**

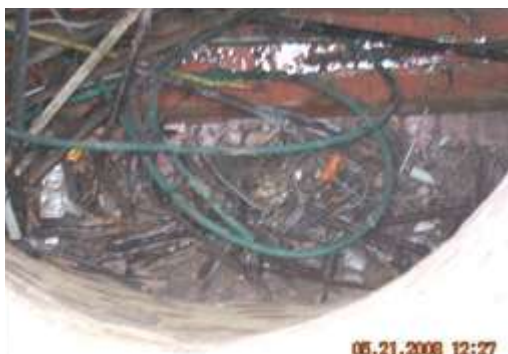
Defect 3

Condition: ☐ Sound ☐ Cracked ☐ Root Intrusion ☐ Deteriorated ☐ Leaks ☒ **Debris**

debris on bench

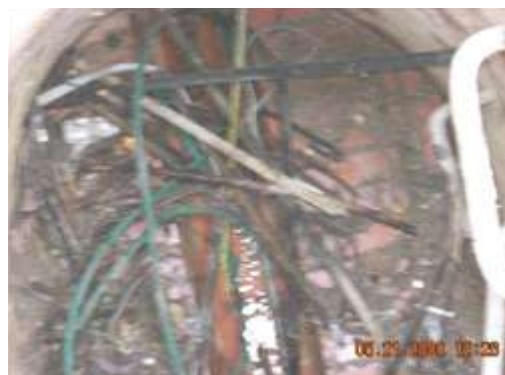
Defect 2

Condition: ☐ Sound ☐ Cracked ☐ Root Intrusion ☐ Deteriorated ☐ Leaks ☒ **Debris**

debris in channel

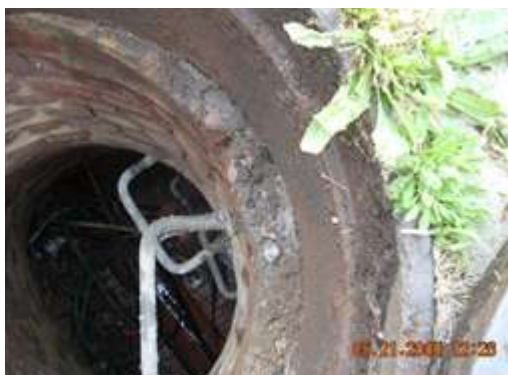
Defect 1

Offset: **2** (in.)

frame offset

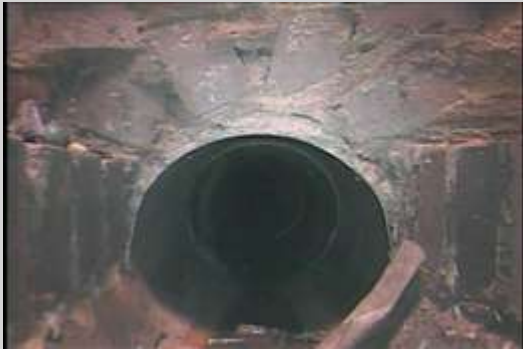
12 O'Clock Outflow

8 in. Circular Gravity Sewer
Pipe Out @ 12 O'Clock

Pipe Height: **8.4** (in.) Rod and Bar (Angled)
Pipe Material: **Clay** ☐ Pipe Lined
Invert Depth: **7.95** (ft.) Flow Characteristics: **None**
Deposits: ☐ None ☐ Mud ☐ Sludge ☒ **Debris** ☐ Grease
Silt Depth: **2** (in.) Deposits Extent: **Light**
Infiltration: **None** Pipe Seal Cond: **Sound**

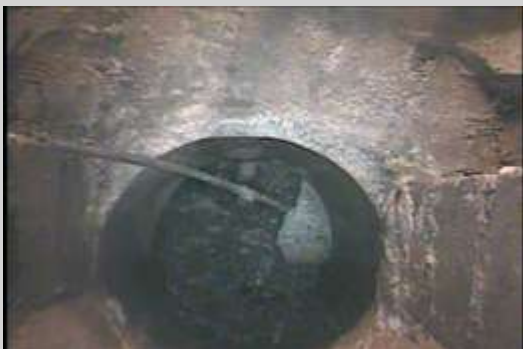
6 O'Clock Inflow

0 in. Circular Gravity Sewer
Pipe In @ 6 O'Clock

Connects To: **Stub connection / abandoned**
